# MINA FLORIDA HOME INSPECTIONS FOUR POINT INSPECTION REPORT

Address: 123 Address Ln.

Inspection Date: 01/20/2026

# 4-Point Inspection Form

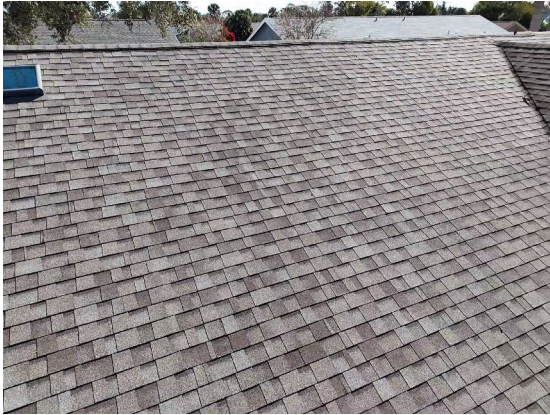
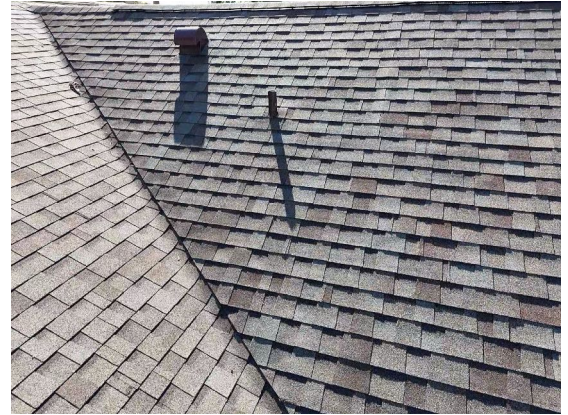
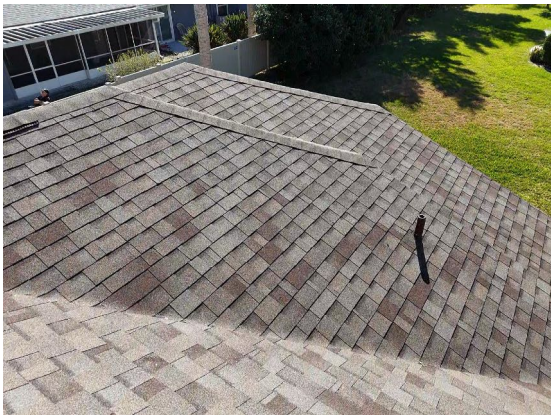
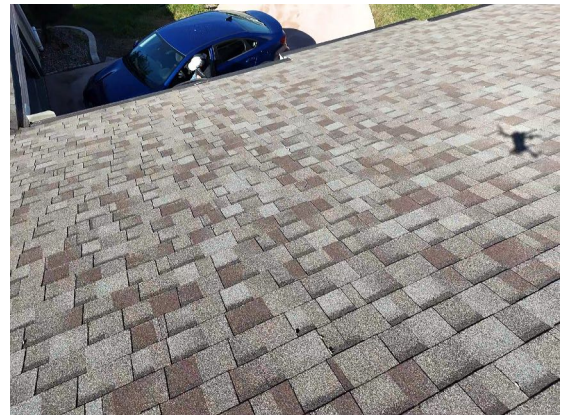
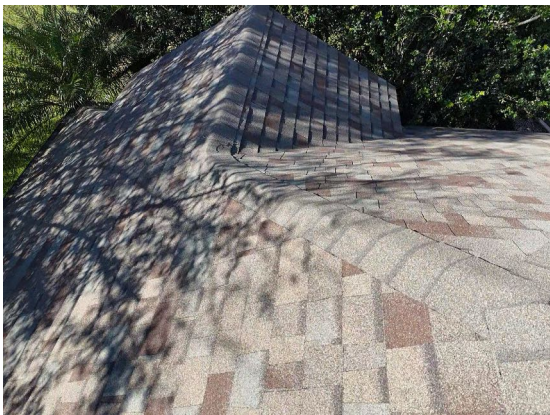
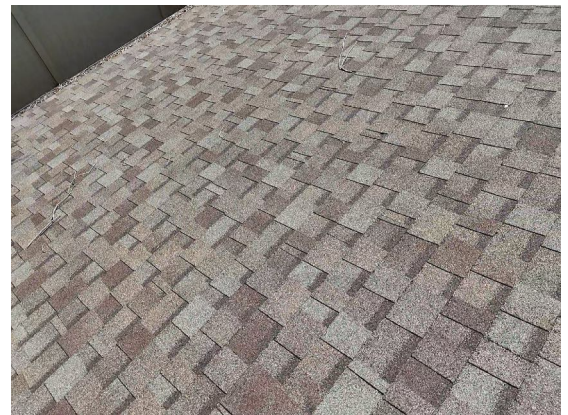
Roof: New roof in 2023.

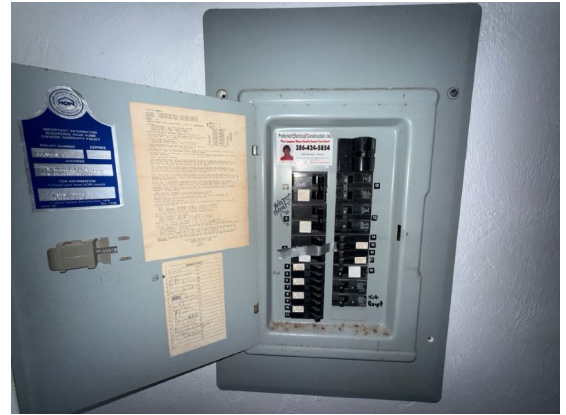
Main Electrical Panel

Electric: All electric appears to be in working order.

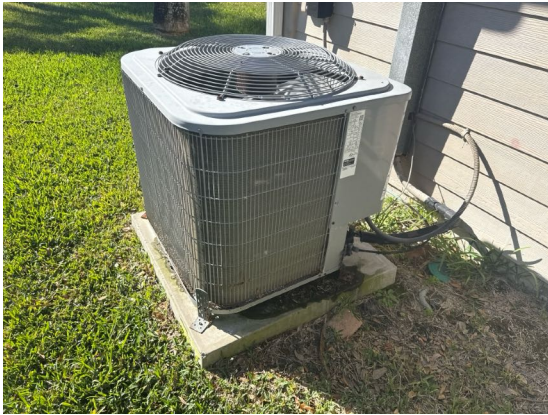
Compressor 1

HVAC: New HVAC in 2022.

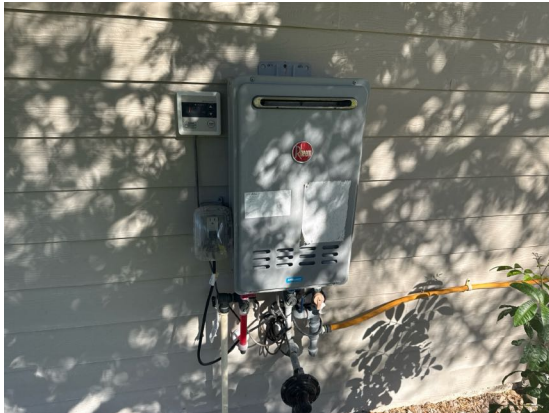
Propane Water Heater

Plumbing: New water heater in 2023.
