## MINA FLORIDA HOME INSPECTIONS WIND MITIGATION INSPECTION REPORT

Address: 123 Address Ln.

Inspection Date: 01/20/2026

# Uniform Mitigation Verification Inspection Form

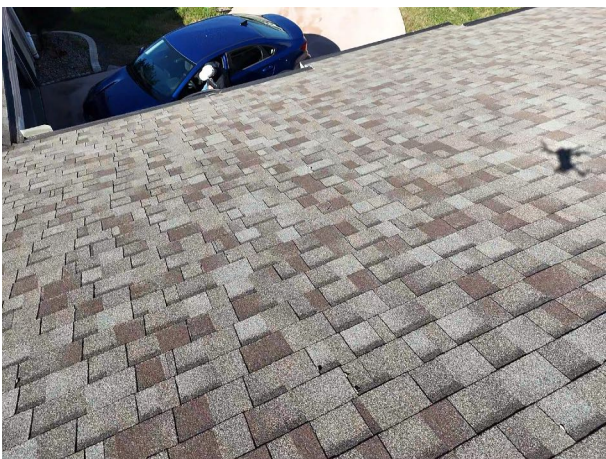
| 2.1 Roof Covering Type: | Permit Application Date | Permit #<br>FBC or MDC<br>Product Approval # | Year of Original Installation or Replacement | No Information Provided for Compliance |
|---|---|---|---|---|
| <input checked="" type="checkbox"/> 1. Asphalt/Fiberglass Shingle | 01/12/2022 | 7266-2378 | 2022 | <input type="checkbox"/> |

- ☒ A. All roof coverings listed above meet the FBC with a FBC or Miami-Dade Product Approval listing current at time of installation OR have a roofing permit application date on or after 3/1/02 OR the roof is original and built in 2004 or later.

**30 Year Architectural Asphalt Shingles**

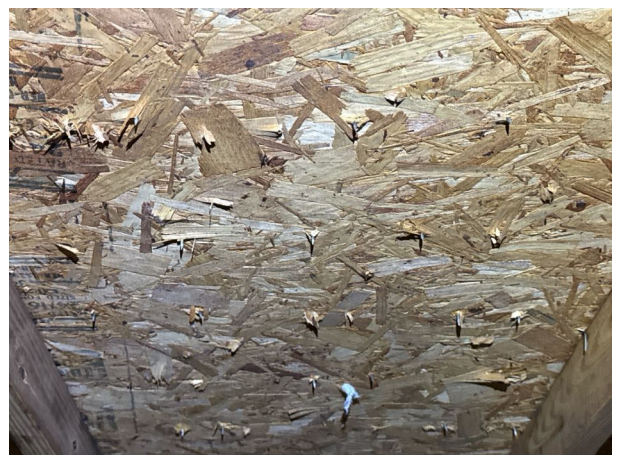
**6 Nails Per Shingle From Roof Underside**

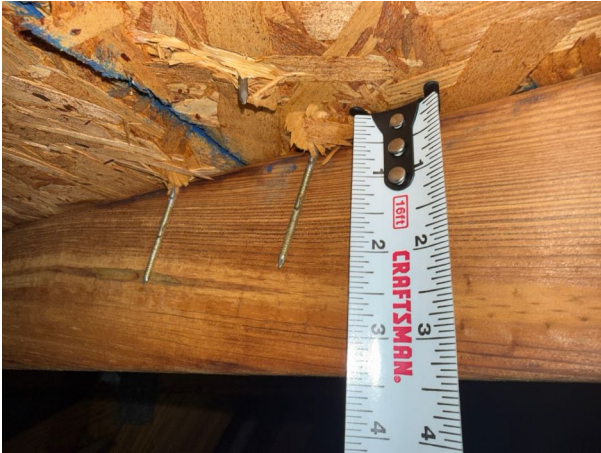
- ☒ C. Plywood/OSB roof sheathing with a minimum thickness of 7/16" inch attached to the roof truss/rafter (spaced a maximum of 24" inches o.c.) by 8d common nails spaced a maximum of 6" inches in the field. -OR- Dimensional lumber/Tongue & Groove decking with a minimum of 2 nails per board (or 1 nail per board if each board is equal to or less than 6 inches in width). -OR- Any system of screws, nails, adhesives, other deck fastening system or truss/rafter spacing that is shown to have an equivalent

8d Nails Used For Roof Deck Attachment

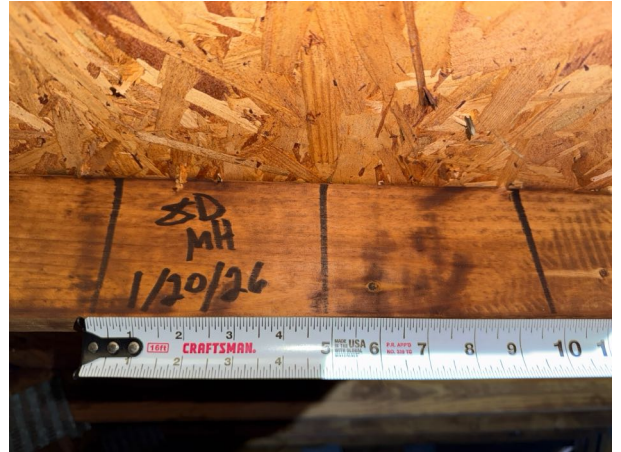
or greater resistance than 8d common nails spaced a maximum of 6 inches in the field or has a mean uplift resistance of at least 182 psf.

8d Nails Spaced 6" by 6"

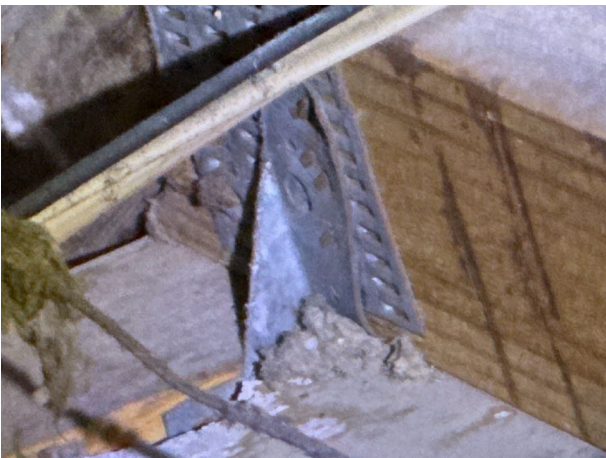
- ☒ Secured to truss/rafter with a minimum of three (3) nails, **and**
- ☒ Attached to the wall top plate of the wall framing, or embedded in the bond beam, with less than a ½" gap from the blocking or truss/rafter **and** blocked no more than 1.5" of the truss/rafter, **and** free of visible severe corrosion.

- ☒ B. Clips
  - ☒ Metal connectors that do not wrap over the top of the truss/rafter, **or**
  - ☐ Metal connectors with a minimum of 1 strap that wraps over the top of the truss/rafter and does not meet the nail position requirements of C or D, but is secured with a minimum of 3 nails.

Hurricane Clip Roof To Wall Attachment

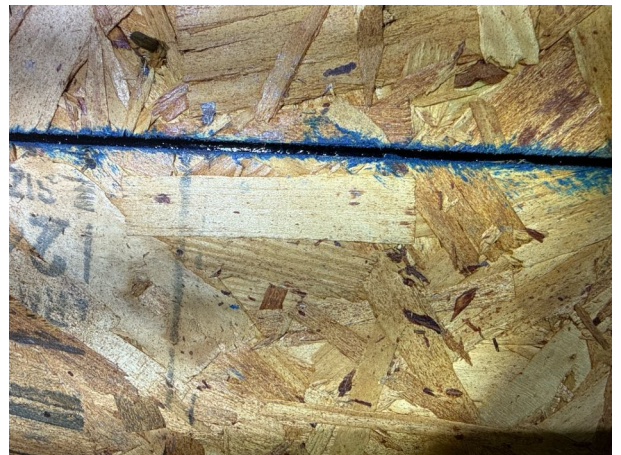
- ☒ A. SWR (also called Sealed Roof Deck) Self-adhering polymer modified-bitumen roofing underlayment applied directly to the sheathing or foam adhesive SWR barrier (not foamed-on insulation) applied as a supplemental means to protect the dwelling from water intrusion in the event of roof covering loss.
- ☐ B. No SWR.
- ☐ C. Unknown or undetermined.

SWR

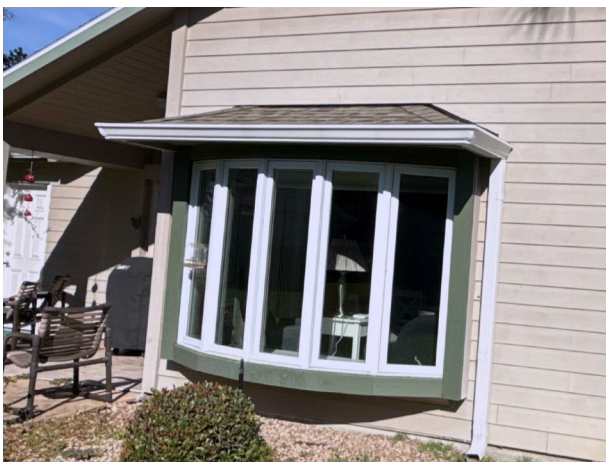
| Opening Protection Level Chart<br>Place an "X" in each row to identify all forms of protection in use for each opening type. Check only one answer below (A thru X), based on the weakest form of protection (lowest row) for any of the Glazed openings and indicate the weakest form of protection (lowest row) for Non-Glazed openings. | | Glazed Openings | | | | Non-Glazed Openings | |
|---|---|---|---|---|---|---|---|
| X | No Windborne Debris Protection | <input checked="" type="checkbox"/> | <input type="checkbox"/> | <input checked="" type="checkbox"/> | <input type="checkbox"/> | <input checked="" type="checkbox"/> | <input checked="" type="checkbox"/> |

Non Impact Bay Windows
